2001-2002 GRAND JURY REPORT

Riverside County

Department of Mental Health

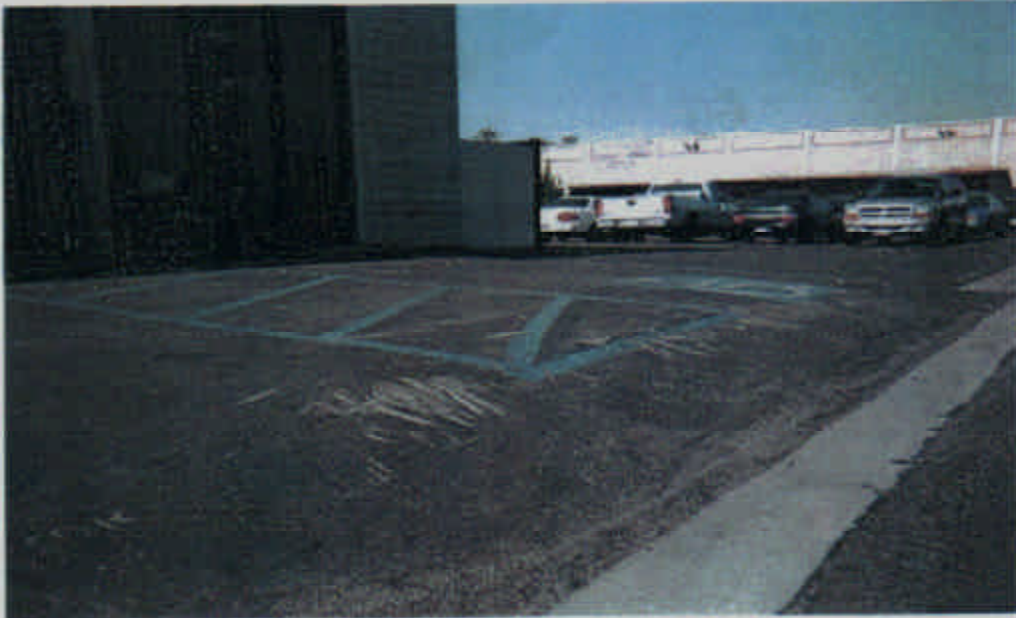
2. A Grand Jury field inspection conducted on November 27, 2001, revealed the handicapped parking area, located at the east end of the building, was placed on a dangerously steep slope. This made moving on the surface difficult for handicapped persons in wheelchairs and walkers to navigate their way up or down the parking ramp. ADA regulations require a gradient of not more than 2 percent in any direction. (Ref: paragraph 4D, Surface Parking Space Design, page 154, dated c2000PCC) The grade at that time revealed a steep slope that was in excess of 20 percent. (Figure 1 and 2)

4. The asphalt surface of the parking area was irregular with deep grooves created by vehicles scraping the asphalt when parking on the steep incline. (Figure 1) These grooves were a hazard, especially, for handicapped people using walkers or wheelchairs.

Figure 1 - View of Mental Health parking lot showing slope and grooves in the pavement (11/27/01)

1. Board of Supervisors direct all department heads to adhere to and enforce annual inspection schedules on all owned or leased properties, as required by paragraph IV-A, County of Riverside Standard Safety Operations Manual, revised 3/1/97.
2. County Safety Department, ADA Coordinator, Facilities Management, and all appropriate city and county agencies inspect all county owned and leased buildings and grounds to insure they meet current ADA, fire, health and safety regulations before a certificate of occupancy is issued and the facility is occupied.
3. Continue to make appropriate repairs to all facilities bringing them up to current codes and safety regulations.

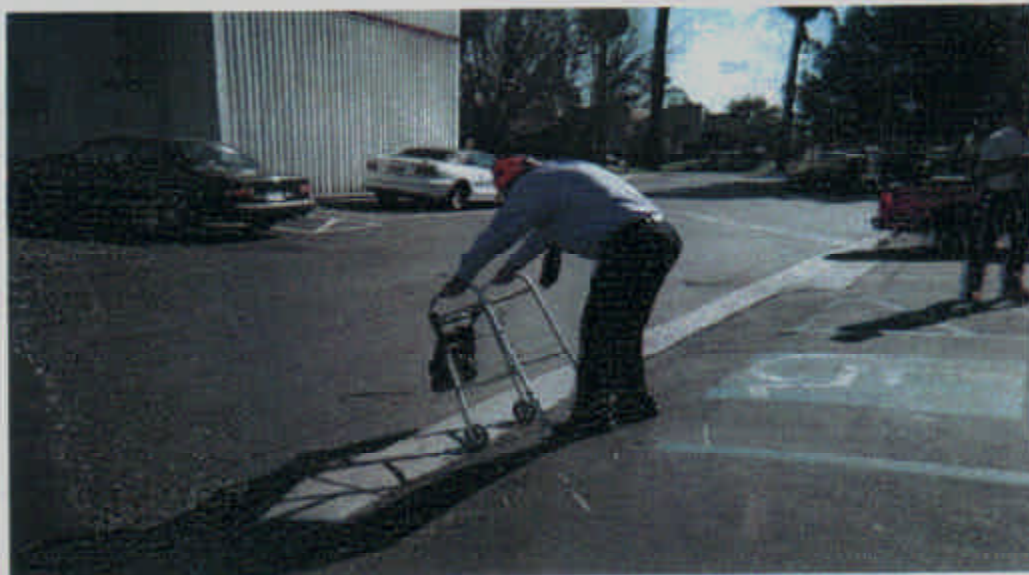
Figure 2 - Difficulty in using a walker or a wheelchair on steep slope (11/27/01)

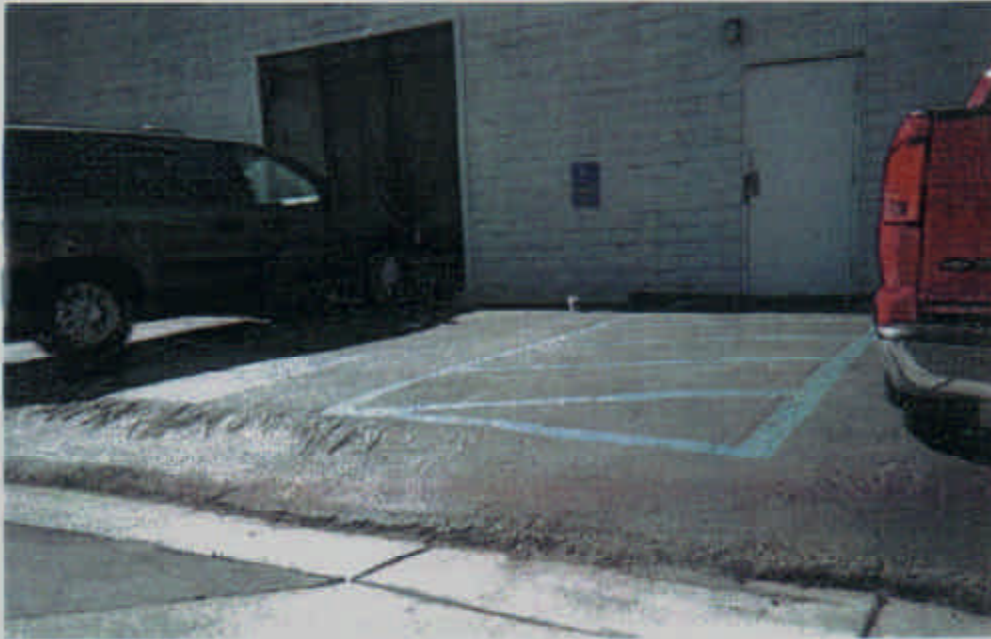
3. A 36-inch walkway between the front of parked vehicles and an adjacent building's walls was not available at the Mental Health Facility. (Figure 3 and 4) This violation forced patrons to walk behind several parked vehicles in order to gain access to the building. (Ref: paragraph 3, page 154, Code 1129B.4.3, Arrangement of Parking Spaces of The California Disabled Accessibility Guidebook states, "Accessible parking spaces are located such that they do not compel users to travel behind parked cars other than their own.")

Figure 3 - Narrow space between vehicle and wall. ADA rules require three feet (11/27/01).

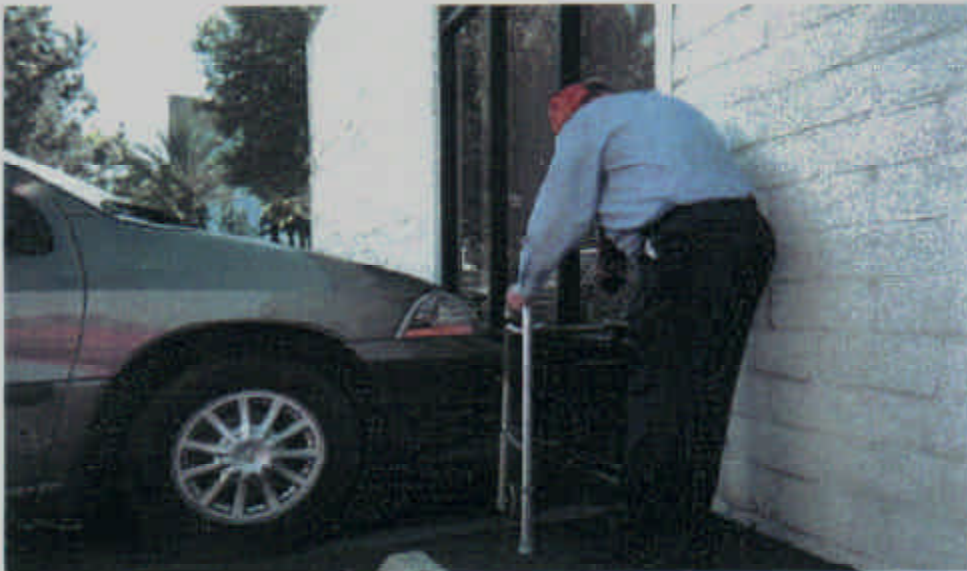
Figure 4 - Impossibility of using a walker or wheelchair between vehicle and wall (11/27/01)
